## MUNICIPAL SEPARATE STORM SEWER SYSTEM PERMIT 2024 ANNUAL REPORT

FOR THE LEXINGTON CAMPUS OF THE

### 2024 KYG20 GENERAL PERMIT ANNUAL COMPLIANCE REPORT

PART A: GENERAL INFORMATION – MS4 OPERATOR						
1.	Report Completed By:	University of Kentucky (MS4 Operator — i.e., name of permit holde	)				
2.	Permit Number: K Y	G 2 0 0 0 5 2 AI#1104 4	Population: 63,999 (34,000 S	tudents, 29,999 Employees)			
5.	5. Mailing Address Street Address: 355 Cooper Drive						
		kington, KY	Zip: 40506	County: Fayette			
PART B: GENERAL INFORMATION – CONTACT PERSON							
6. Contact Person Name (please print): Kevin Lewis

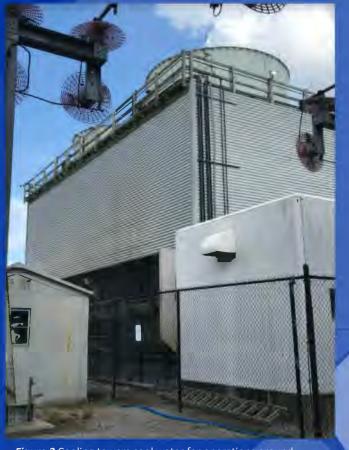
Figure 2 Cooling towers cool water for operations around campus. Photo taken by Jennifer Bukowski on August 29, 2023.

Figure 2 Cooling towers cool water for operations around campus. Photo taken by Jennifer Bukowski on August 29, 2023.

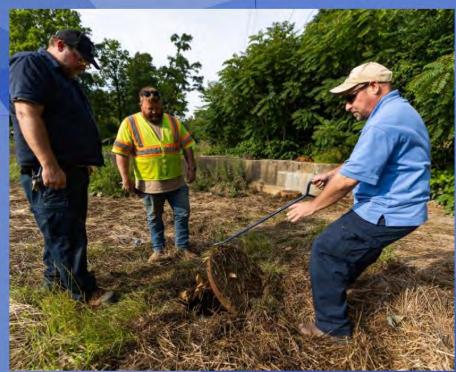
Figure 6 Regular cleaning of the system helps maintain its integrity and improve

Figure 6 Regular cleaning of the system helps maintain its integrity and improve

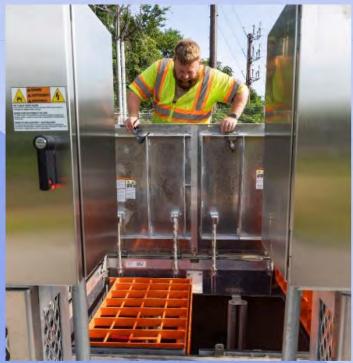
*Figure 8* One improvement to the system may be adding a chemical line that can treat the water in the wet well. Photo taken by Arden Barnes on July 7, 2023.

Figure 8 One improvement to the system may be adding a chemical line that can treat the water in the wet well. Photo taken by Arden Barnes on July 7, 2023.

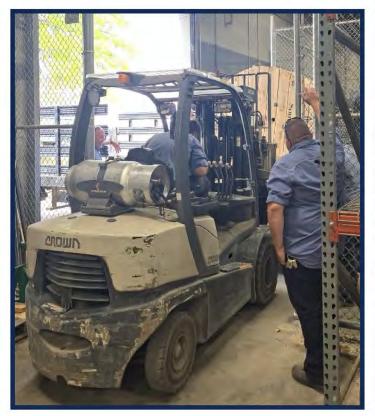
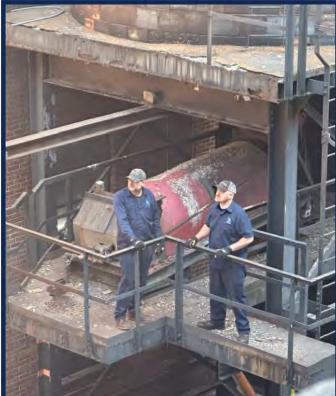
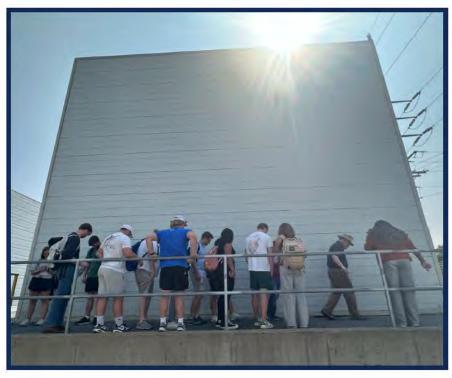
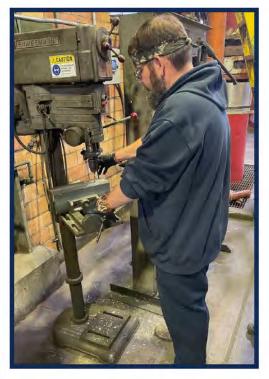
**Top L:** Gary Helton unloads wire from Elliot while Scott Barnes and Mike Smith offer moral support. **Top R:** Chris Keely and Chad DeRossitt contemplating life and plans for unloading the ash silo. **Bottom L:** Graham Gray gives tour of CUP cooling tower & stormwater system to Civil Engineering senior design students. **Bottom R:** Matt True of Med Center fabricating a bracket of a pump coupling guard.

- new bracket for the coupling guard on system pump #3. Worked with DJ Enterprises to replace fuel tank sensors. Got boiler #4's new VFD fan drive working with the supply contractor and Larry White.

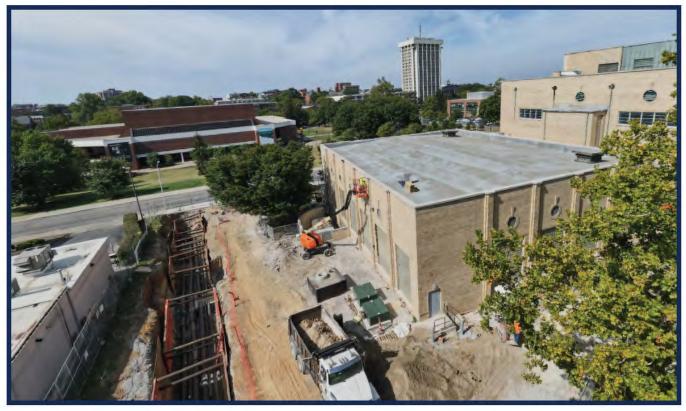
**Top L:** John Nord's snapshot of Friday morning's rainbow over the Singletary Center. **Top R:** Chris Keely caught the rainbow over Central Heating's boiler stacks. **Bottom:** With the help of ITS Infrastructure Operations GIS, UEM and CPMD gathered images of the new north campus utility infrastructure being installed in support of the Memorial Coliseum renovation. The drone images are then integrated into a GIS software model for future reference.

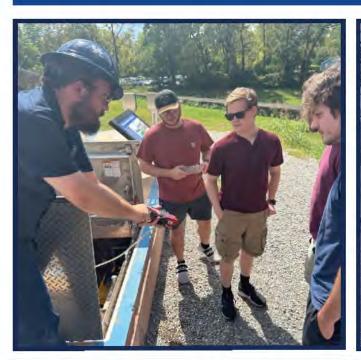
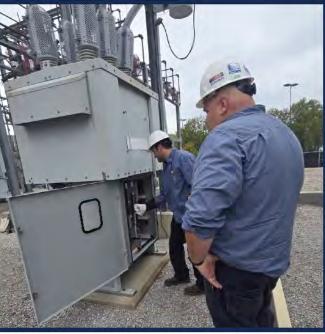
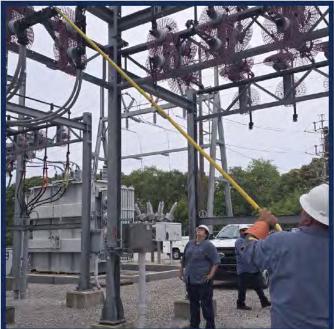
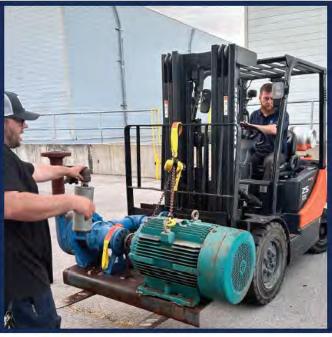
Top L: Orion Saunier sharing information about air monitoring for confined spaces with an engineering senior design team. Top R: John Nord and Bryan Poe operate a breaker at substation #3. Bottom L: Scott Barnes and Shelby King operate an overhead disconnect ("knife switch") at substation #3. Bottom R: Jon Minton and Will Tyree taking old DA pump out for service.

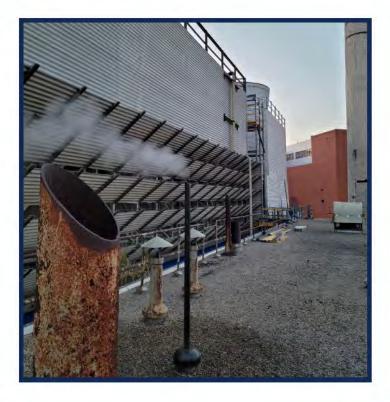
**Top Left:** The new and improved vent for the old DA tank at the Med Center plant. **Right**: David Derenge clearing the automatic blowdown at Cooling 1.

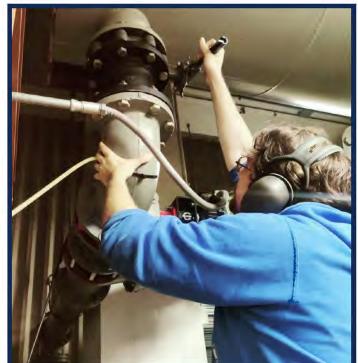
Top L: Not to be confused with Hurricane Helene on radar—thermography of a large chiller circuit breaker in Cooling 1 revealed unusually high and unbalanced temperatures. Shoutout to plant staff for noticing a potential issue and alerting the high voltage team so that the breaker could be safely removed from service before causing any damage to surrounding gear! Top R: The high voltage team removing the suspicious breaker from its cabinet.

- Checked status of low voltage power in vaults at health education building job site
- Responded to call from Henry Huffines at Cooling 1 who was concerned with heat and smell coming from secondary breaker for chillers 3 and 6; took temperature readings and removed breaker from service, upon further inspection found breaker was near point of failure
- 811 locates at Washington Ave at college of health building
- Crews performed scheduled power outage at 6am Thursday to separate power feed to Scovell and Erikson hall, feed to Scovell was permanently removed, power was restored promptly to Erikson
- Crews returned to Cooling 1 to perform thermal scans of 5 similar breakers to assess condition

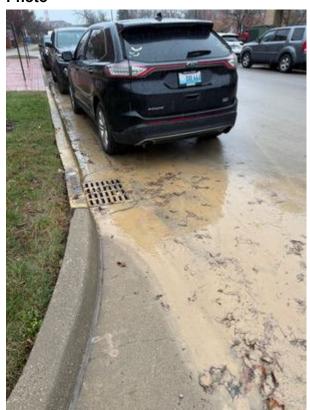
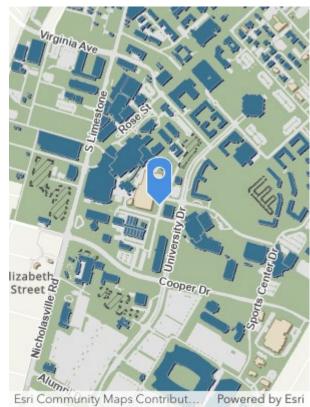
# **Photo**

Reported Description	EQM Water Quality Intern reports appearance that no BMP installed to nearby curb inlet and inlet grate in roadway. General construction gravel/dirt is sprawling and debris could impact stormwater with next rainfall.
Date and Time Observed	October 18, 2024 12:46 PM
Location Description	Curb inlet near intersection of Washington Ave/Library Dr ongoing construction near Scovell (Sanitary line renovation project)
Confirmation	Confirmed - Discharge/Issue Present
Official Description	No BMPs installed near Washington sanitary line renovation area.
Investigation Findings	Gravel/debris in roadway. No curb inlet BMP installed, but filter present in roadway drain.
Corrective Action	Stormwater Inspector (Richard McClure) contacted by EQM to inspect the area. CM Supt. to sweep gravel, add curb inlet protection, & clean/replace street inlet fabric.

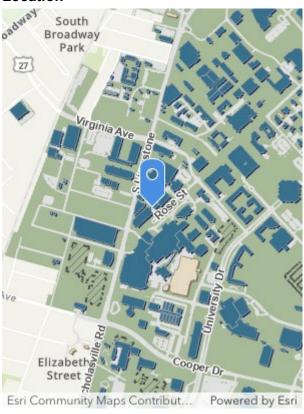
### **Photo**

Reported Description	Facilities staff rinsing drum out at Wethington loading dock area into trench drain. Water appeared dirty.
Date and Time Observed	February 23, 2024 3:57 PM
Location Description	Loading dock between Wethington and Nursing.
Confirmation	Confirmed - Discharge/Issue Present
Official Description	Potential drum/trash can wash out in loading dock area.
Investigation Findings	Washout no longer taking place at the time of investigation. Loading appeared wet.
Corrective Action

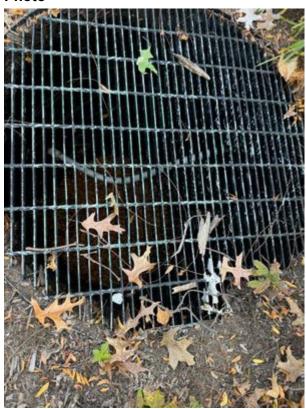
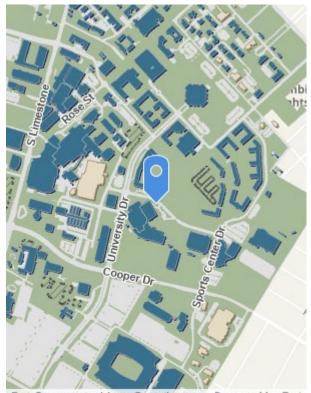
# **Photo**

Reported Description	UK OHS Aaron Sisco reported possible paint splash discharge into storm drain near Aquatics Center.
Date and Time Observed	October 28, 2024 3:18 PM
Location Description	Along landscaped area in between Lancaster Aquatics Center pedestrian entrance & driveway to Johnson Center. Line of site from grate is directly across from Turner Construction Gate 9.
Confirmation	Invalid - Unrelated Issue
Official Description	Green paint splashed onto electrical access grate
Investigation Findings	EQM investigated report of paint discharged to storm drain. Paint was was not fresh, only exists on grating. Grate in question is electrical access, not stormwater related. Issue is closed.
Corrective Action

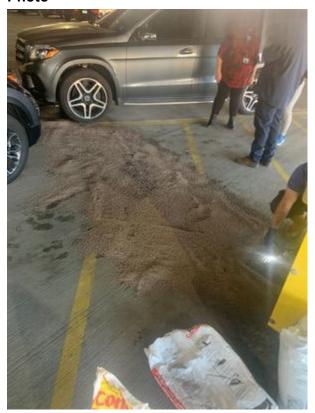
# Photo

Reported Description	Anti-freeze leaked from vehicle broken hose and small amount entered storm drain.
Date and Time Observed	October 24, 2024 8:46 AM
Location Description	4th level of new addition of the Cornerstone Garage located on S Limestone.
Confirmation	Confirmed - Discharge/Issue Present
Official Description	Anti-freeze leaked from vehicle broken hose into storm drain.
Investigation Findings	EQM responded to reported vehicle anti-freeze leak at parking garage. Staff visually confirmed an undetermined amount of liquid entered adjacent storm drain. Contacted vehicle owner arrived to inspect engine compartment to confirm broken coolant line.
Corrective Action	EQM staff applied stay dri absorbent to affected area. Absorbent was swept up, bagged, & disposed to off-site dumpster. No further action required.

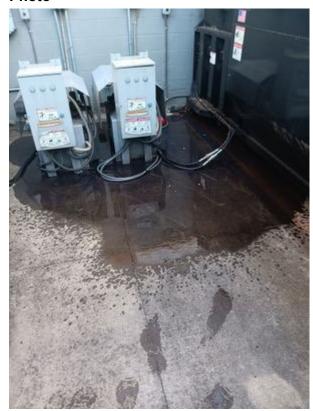
# Photo

Reported Description	UK Grounds staff reported hydraulic hose leaking oil from a garbage compactor outside Holmes Hall. Oil spill entered the trench drain behind compactor but did not extend further into the stormwater system.
Date and Time Observed	October 17, 2024 11:59 AM
Location Description	Within the trash/recycling compactor enclosure located on southeast corner of Holmes Hall entering into trench drain behind garbage compactor.
Confirmation	Confirmed - Discharge/Issue Present
Official Description	Hydraulic oil spill from trash compactor line.
Investigation Findings	Waste hauler failed to disconnect lines from compactor prior to removal. Hydraulic fluid spilled onto concrete pad with a small amount entering trench drain at the back of the pad.
Corrective Action	Trench drain inspected & confirmed oil entered but contained within trench. Oil absorbent applied to impacted area (and removed) by Grounds staff.

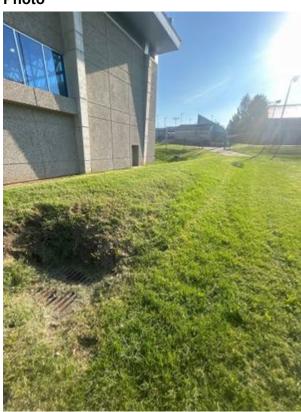
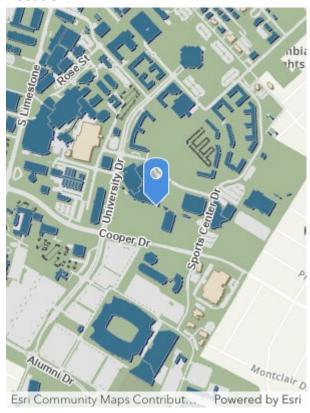
# Photo

Reported Description	Flow present in drain in Pieratt Fields
Date and Time Observed	October 4, 2024 9:55 AM
Location Description	Drain is in Pieratt Fields next to walk way to Boone Center. Drain is in the side of the mound
Confirmation	Declined - No Evidence of Discharge/Issue
Official Description	Dry weather flow in storm drains adjacent to building.
Investigation Findings	Area drains carry natural groundwater flow as has been determined from previous studies.
Corrective Action

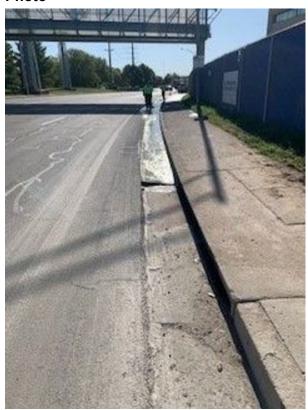
### **Photo**

Reported Description	A large volume of bore drilling slurry (Tru-Bore mixed with water) spilled onto the sidewalk and street and entered two storm drains. The stormwater system is under LFUCG ownership and information was forwarded for follow-up and enforcement.
Date and Time Observed	October 11, 2024 2:12 PM
Location Description	Slurry spilled onto Cooper Drive sidewalk/street and entered two storm water drains along Cooper Drive and Nicholasville Road.
Confirmation	Confirmed - Discharge/Issue Present
Official Description	Drilling sediment slurry entered storm drain.
Investigation Findings	Issue originally reported to LFUCG via 311 and referred to UK via Gabe Hensley on 10/10/24 @ 0906. EQM Nathan Weber sent to investigate. LFUCG contractor spilled drilling slurry while installing fiber optic line. Sidewalk, road, and storm drains impacted.
Corrective Action	Photographs were taken of the spill area and & contractors interviews were conducted. Information was forwarded to LFUCG for follow-up investigation and enforcement as the road and storm drains are under LFUCG ownership.

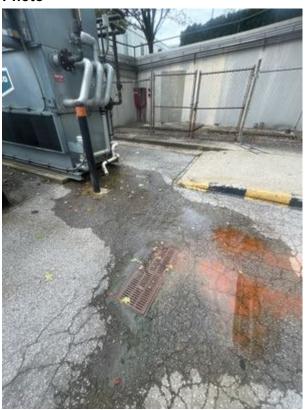
#### Photo

Reported Description	Evapco machine behind chem phys is discharging fluid to drain also there is orange substance next to drain
Date and Time Observed	September 30, 2024 4:41 PM
Location Description	Behind Chem Phys on library drive next to back door entrance by machinery
Confirmation	Declined - No Evidence of Discharge/Issue
Official Description	Condensate from Evapco Unit.
Investigation Findings	Investigation found condensate from cooling unit intentionally discharging to drain under normal operation. Met technician who confirmed.
Corrective Action

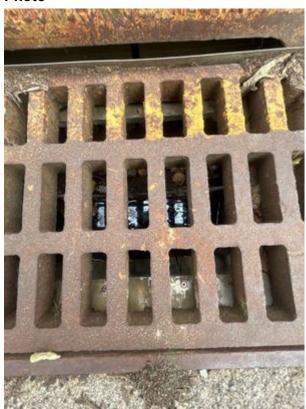
#### **Photo**

Reported Description	Illicit material shimmering in drain
Date and Time Observed	September 18, 2024 2:03 PM
Location Description	Drain is at entrance to CP 2 across from water treatment
Confirmation	Declined - No Evidence of Discharge/Issue
Official Description	Oil sheen in stormwater BMP adjacent to coal pile.
Investigation Findings	Area experienced recent rainfall which debris has accumulated in the storm drain inlet filter BMP. The sheen is from organic litter decomposition, not petroleum. Recommend appropriate staff check BMP to see if maintenance/replacement.
Corrective Action

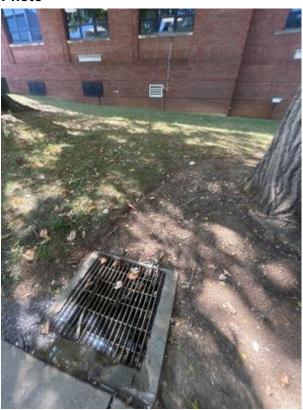
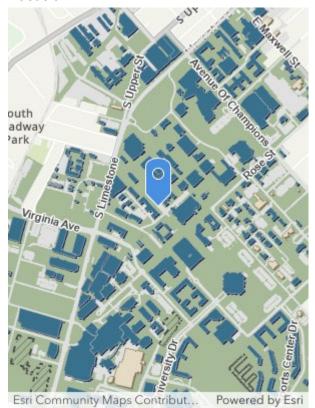
#### Photo

Reported Description	Drain seems clogged and over filling in front of funkhouser
Date and Time Observed	September 16, 2024 12:49 PM
Location Description	In front of funkhouser and parking lot to the left of the building
Confirmation	Confirmed - Discharge/Issue Present
Official Description	Storm drain clogged with debris including sediment and leaves
Investigation Findings	Storm drain clogged preventing stormwater from properly draining
Corrective Action	Drain assessed and marked clogged in storm tracker. Grounds notified. Inlet does not drain properly, historical issue. Will possibly be repaired during renovation.

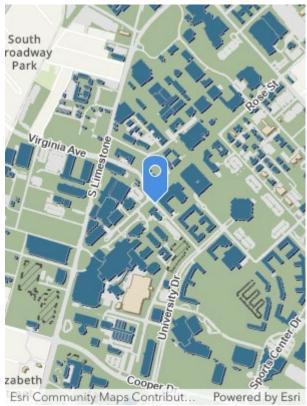
#### **Photo** Location

Reported Description	Utility construction trench being dewatered without BMPs in place. Sediment laden water being discharged down street.
Date and Time Observed	February 23, 2024 4:26 PM
Location Description	Corner of Rose Street and Huguelet Drive adjacent to Cooper Bldg.
Confirmation	Confirmed - Discharge/Issue Present
Official Description	Sediment laden stormwater being pumped from construction trench.
Investigation Findings	Contractor dewatering utility construction trench without using required BMPs. Sediment laden water discharging down street towards storm drain.
Corrective Action	UEM notified of issue. On 6/30 contractors were observed pumping stormwater into nearby steam vault with sump pump to sanitary. Contractor instructed to discharge to storm sewer while using dewatering bag.

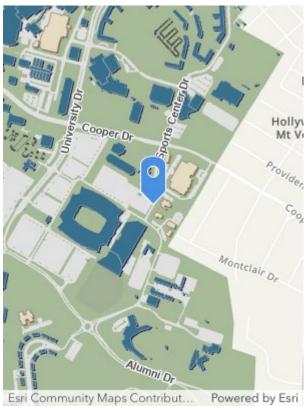
#### Photo

Reported Description	Water bubbling from the ground near the Ronald McDonald House along the roadway. Gravel is being washed into the roadway.
Date and Time Observed	February 23, 2024 1:12 PM
Location Description	Along Sports Center Drive in the grass swale along the roadway between RMH and K Club.
Confirmation	Invalid - Unrelated Issue
Official Description	Water bubbling from ground along roadway
Investigation Findings	Stormwater moving through stone placed in grass swale and popping up on other side of grass pathway. Swale capacity reduced due to rock lining causing overflow onto roadway. Remediation required.
Corrective Action

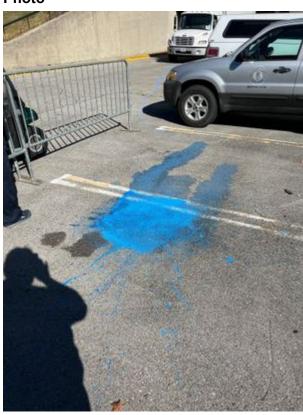
#### **Photo**

Reported Description	Paint spill at Tobacco Research loading dock area.
Date and Time Observed	February 23, 2024 12:38 PM
Location Description	Begins at Tobacco Research loading dock area and tracks towards roadway.
Confirmation	Confirmed - Discharge/Issue Present
Official Description	Paint spill caused by improper disposal.
Investigation Findings	Improper disposal of paint by contractor during renovation work.  Water soluble paint requiring clean up.
Corrective Action	UK Facilities contacted. Paint required to be cleaned up properly without discharge to storm sewer.

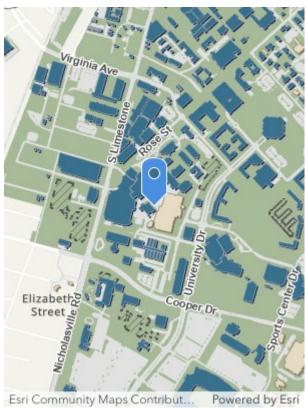
#### **Photo**

Reported Description	Med Center Heating Cooling Condenser Tank overflowing white substance on ground and into adjacent storm drains.
Date and Time Observed	February 21, 2024 2:51 PM
Location Description	Blue tank at the back of Med Center Heating and Cooling between Pav A and the VA.
Confirmation	Confirmed - Discharge/Issue Present
Official Description	Med Center Heating and Cooling Condenser Water Tank overflowing and entering storm sewer.
Investigation Findings	Tank overflowing and entering storm sewer.
Corrective Action	Mike Duffy - UEM contacted to resolve issue

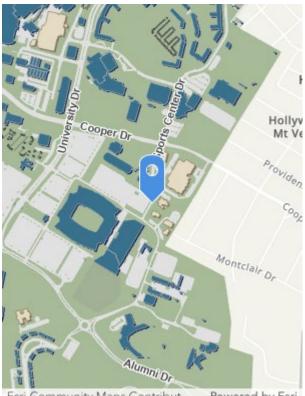
#### Photo

Reported Description	Water bubbling up from ground near Ronald McDonald House adjacent to roadway and gravel washing out in road.			
Date and Time Observed	February 21, 2024 12:01 PM			
Location Description	On side of Sports Center Drive between Ronald McDonald House and K-Club			
Confirmation	Invalid - Unrelated Issue			
Official Description	Rainwater flowing though rocks and popping up on the downstream side of grass pathway giving appearance of water/sanitary leak.			
Investigation Findings	Rainwater back up due to swale being filled with stone and forcing the water out on the opposite side of grass pathway. Excess liner rock filling swale along roadway limiting capacity causing ponding and overflow issues.			
Corrective Action

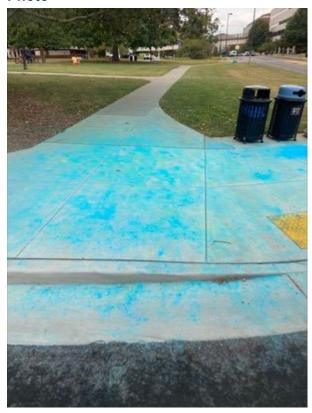
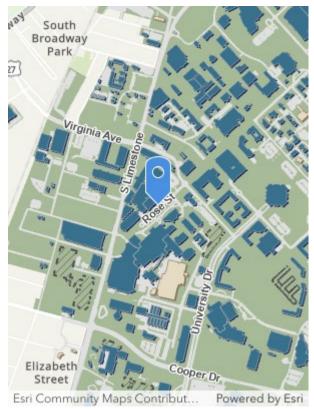
#### **Photo**

Reported Description	Spray chalk and color run bombs on sidewalks and roadways at various locations throughout campus.		
Date and Time Observed	February 21, 2024 9:04 AM		
Location Description	Various sidewalks and roadways throughout campus including those near Wethington, College of Nursing, Huguelet Dr., Rose, Haggin Hall, and Alumni Commons.		
Confirmation	Confirmed - Discharge/Issue Present		
Official Description	Large amounts of colored corn starch dispersed at locations throughout campus along 5K route as part of Color Run event. Spray chalk was also employed to mark the event route.		
Investigation Findings	Color run event held without prior approval from University and without appropriate stormwater controls/clean-up plan in place as required. As a result, color packets were dispersed in multiple locations throughout race route requiring pressure washing.		
Corrective Action	Grounds staff deployed stormwater BMPs and cleaned impacted areas. UK Events Management staff alerted to issues caused by event. Organization fined (required to pay for clean-up) for failure to follow provided protocols.

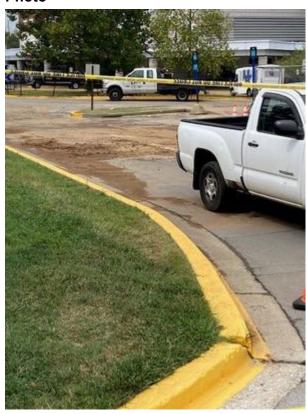
#### **Photo**

Reported Description	Sediment along Hospital Drive flowing from Greenhouses to culvert behind Pav A and Med Center Heating and Cooling.		
Date and Time Observed	February 20, 2024 3:39 PM		
Location Description	Sediment in Hospital Drive roadway and flowing along curb towards storm inlet located between Pav A, Med Center Heating and Cooling, and the VA.		
Confirmation	Confirmed - Discharge/Issue Present		
Official Description	Sediment in roadway, along curbing, and impacting storm drains in area behind PAV A.		
Investigation Findings	Sediment caused by 12" water line break in island adjacent to Hospital Drive. Area storm drains impacted, however, BMP's in place provided some protection.		
Corrective Action	UK UEM contacted. I

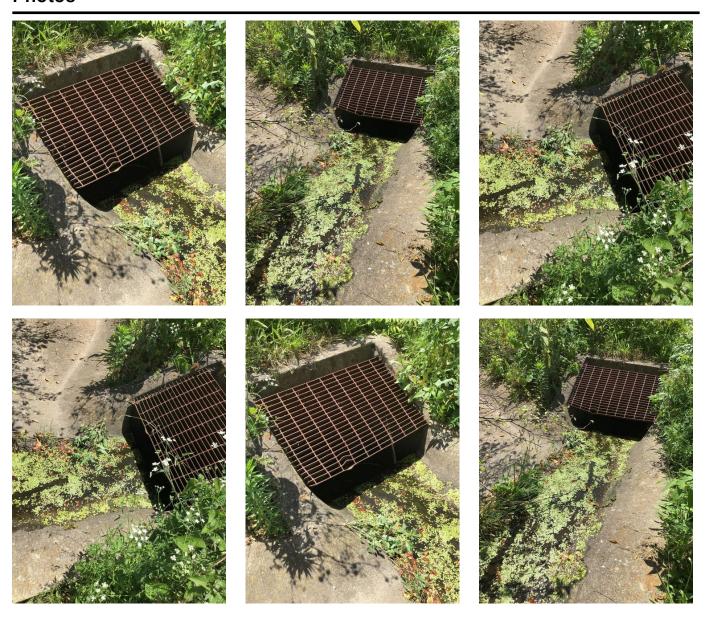
### **Photos**

Overall Outfall Characterization: No	Evidence	Additional Comments:	NA
Additional Information			
Weather			
		T (F):	74
Weather Condition:	Clear	Temperature (F):	74

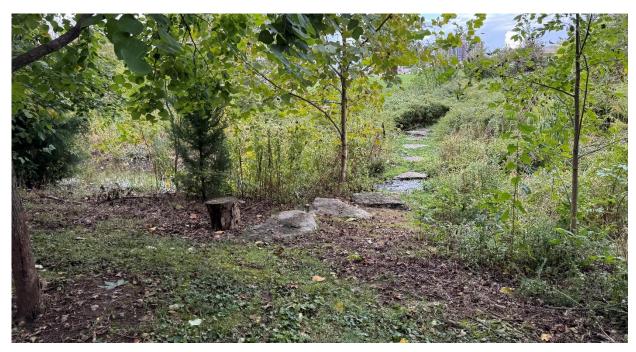
As summer approaches its end, greenspace vegetation is lush and abundant. Our trimmers make short work of what plants grow into the walking paths, maintaining visible and accessible paths across the creek (September).

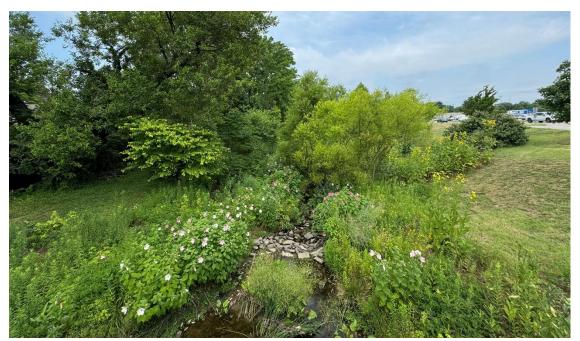
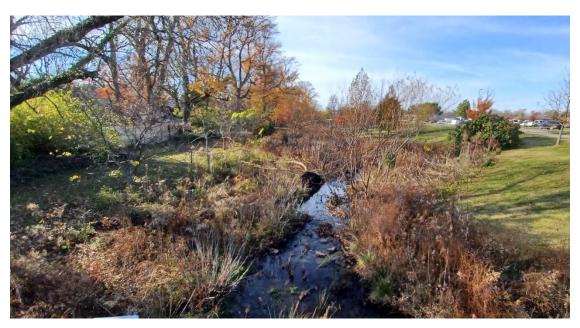
Pictured above are all that remains of the cattail population along this section of stream. We expect less than 10% of cattail that were present at the start of the year will resprout in the spring (November).

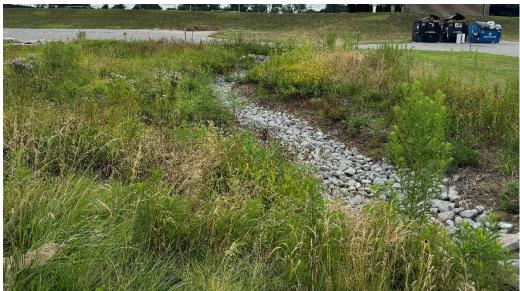
Top: The rock channel provides contrast to the green growth of spring. (April).

Bottom: Spring flowers give way to summer flowers (early July).

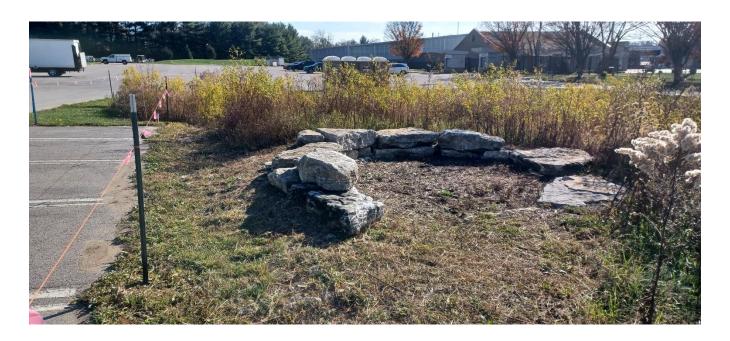
Above: Before and after a trim of the outdoor classroom (November).

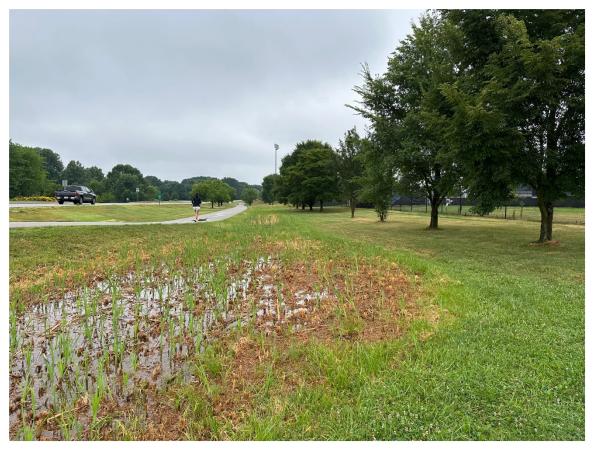
The above images show site conditions on the morning of July 22, 2024 following an approximately 0.17-inch rainfall event. Water is not captured by the existing stormwater infrastructure in the area and has caused damage to a downstream basin.

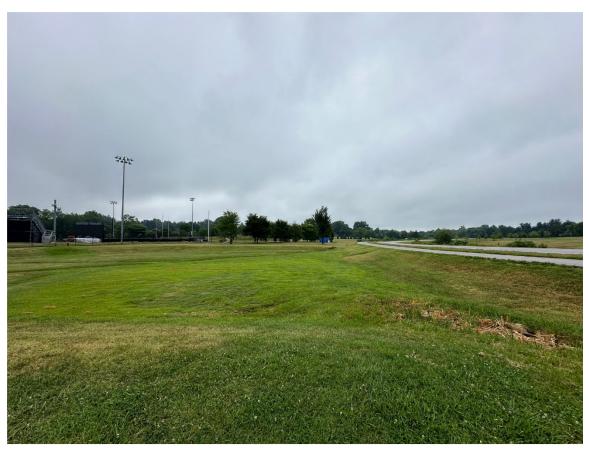
The above image shows the condition of the berm at the existing sedimentation basin. Flow from the project area has eroded the berm as seen in the lower right corner of the image. Further damage to the berm may impact the basin's functionality and cause greater flooding concerns in the project area.

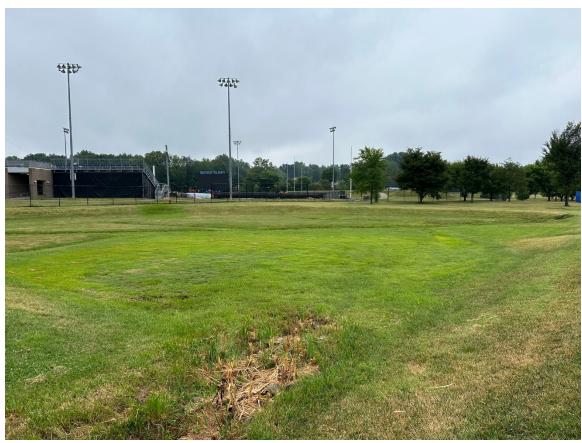
The above image better illustrates erosion damage to the berm of the basin along alumni drive. Flow from the athletics complex has eroded a portion of the berm, leading to the potential of greater stormwater concerns in the project area.

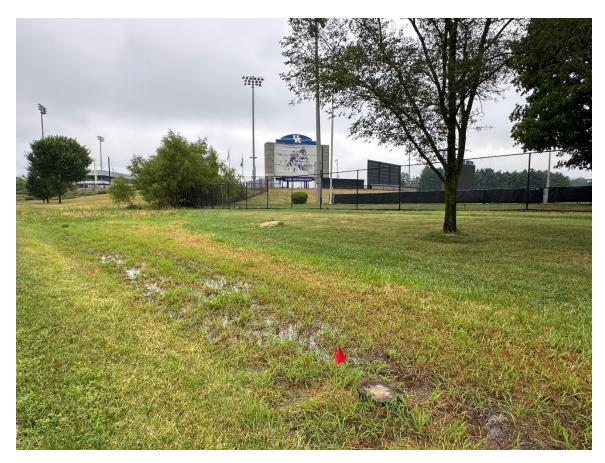
A portion of stormwater in the project area bypasses the existing controls, leading to ponding near Alumni Drive's mixed-use trail. This has resulted in the loss of tree canopy in the area, as the waterlogged soils have become unsuitable for many of the trees planted here. The image above provides an example of a recently removed tree as a result of these conditions.

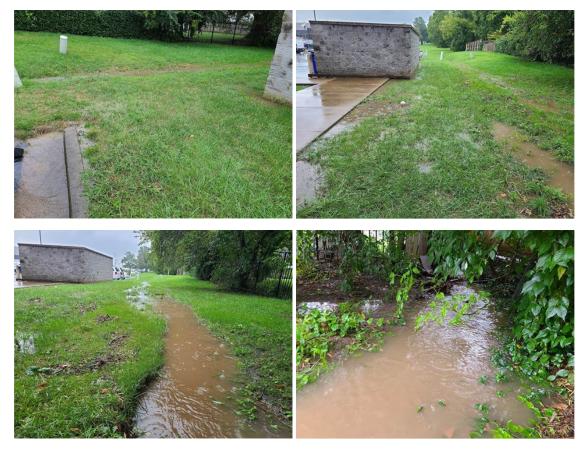
This project will address a noted flooding concern in the Hope Lodge parking area.

Previous efforts mitigated flooding concerns with the installation of a concrete curb. This effort removed the threat of flooding in the building, but flow has been redirected to the parking area. This project will investigate methods of mitigation for this localized flooding.

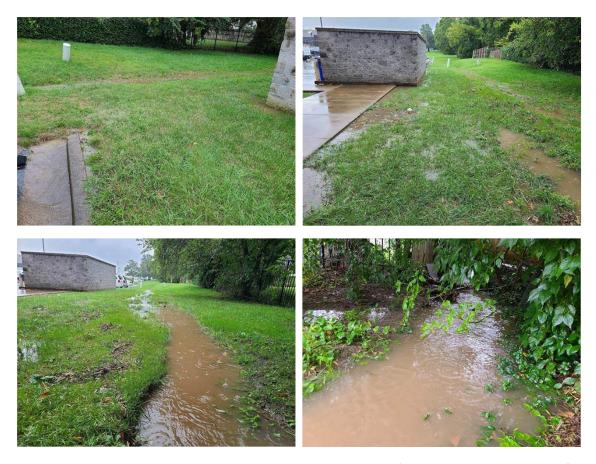
The above images show site conditions prior to the installation of a concrete curb to redirect flow away from the Hope Lodge building. This project was successful in removing flooding concerns from the building basement. However, flooding concerns still exist in the parking area.

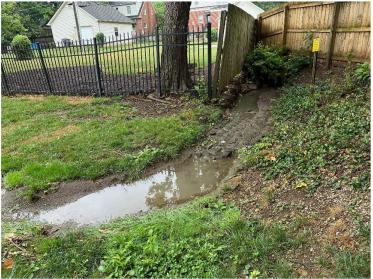
The above images show conditions at the LFUCG outfall from the Montclair neighborhood, located at the head of the grass swale on the Hope Lodge property. Images shown were taken the morning of July 22, 2024.

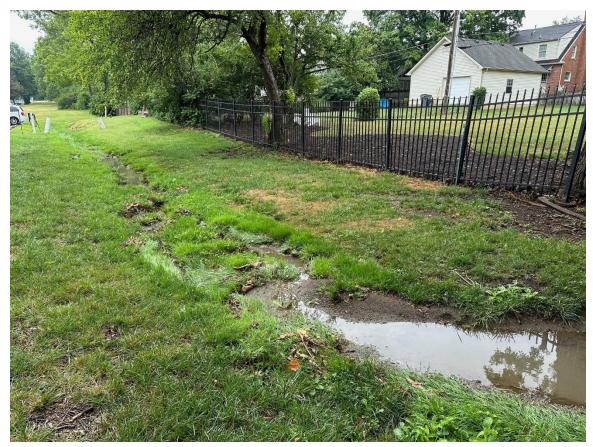
The above image shows the grass swale at the project site. This image was taken on the morning of July 22, 2024 following an estimated rainfall event of approximately 0.17 inches.

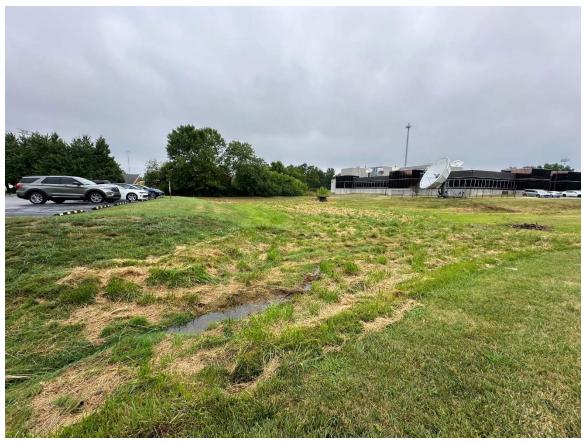
The above image shows the grass swale and basin at the project site. This image was taken on the morning of July 22, 2024 following an estimated rainfall event of approximately 0.17 inches.

Grading repairs are intended for the existing dry detention basin.

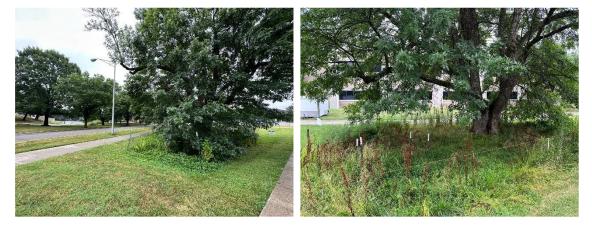
The above images show the location of the spring which has opened by the Oswald Building on Sports Center Drive. The area surrounding the tree pictured has become saturated and poses a potential podestrian hazard, leading University Grounds staff to construct a temporary barrier around the area.

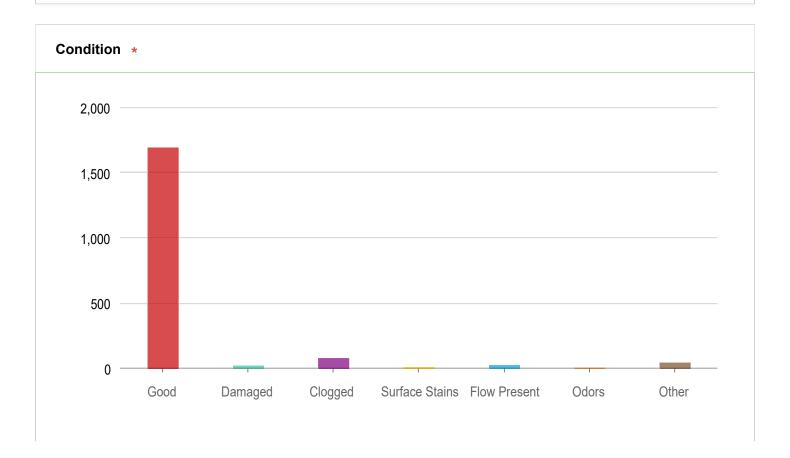
Answered: 1,769 Skipped: 76

Answers	Count	Percentage
Good	1,695	91.87%
Damaged	24	1.3%
Clogged	81	4.39%
Surface Stains	12	0.65%
Flow Present	29	1.57%
Odors	7	0.38%
Other	48	2.6%

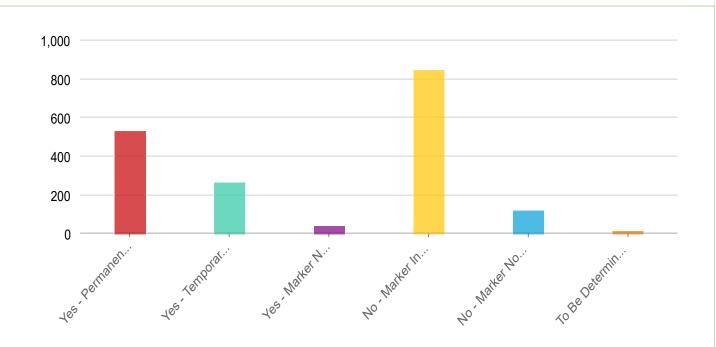
#### Is the structure marked as a storm drain? \*

Answers	Count	Percentage
Yes - Permanently Cast/Lettered	532	28.83%
Yes - Temporary Marker	264	14.31%
Yes - Marker Needs Repair	39	2.11%
No - Marker Install Required	847	45.91%
No - Marker Not Required	119	6.45%
To Be Determined	15	0.81%
